Intel[®] Pentium[®] III Xeon[™] Processor Specification Update

Release Date: November 2003

Order Number: 244460-038

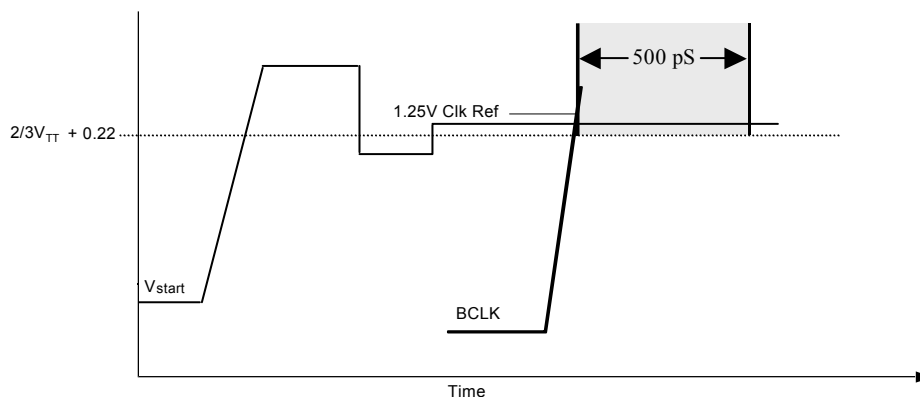
The published AGTL+ AC specification for $V_{IH(MIN)}$ is $(2/3 \cdot V_{TT}) + 0.1$ Volts.

Intel has characterized the new AGTL+ AC specification for $V_{IH(MIN)}$ on the processor's RS0# signal to be: $(2/3 \cdot V_{TT}) + 0.22$ Volts within 500 picoseconds following the rising edge of BCLK crossing the 1.25-Volt threshold. See below.

Implication: The deviation from the published specification results in decreased noise margin on the RS0# processor input. This decreased noise margin has been observed to be particularly detrimental in system environments where the RS0# processor input is being driven by an I/O buffer with a pull-up device (such as a p-channel transistor) that is switched off mid-cycle. Systems that employ I/O buffers that keep the pull-up device on for the entire cycle are significantly less affected by this erratum. The reduction in noise margin may lead to the generation of BINIT# (when enabled) resulting in a system reset, otherwise this condition may lead to a system "hang" condition.

Workaround: If a system design cannot meet the specification deviation, the following areas should be carefully examined to assure that additional margin exists in order to compensate for any deficit observed with respect to the newly characterized $V_{IH(MIN)}$ specification:

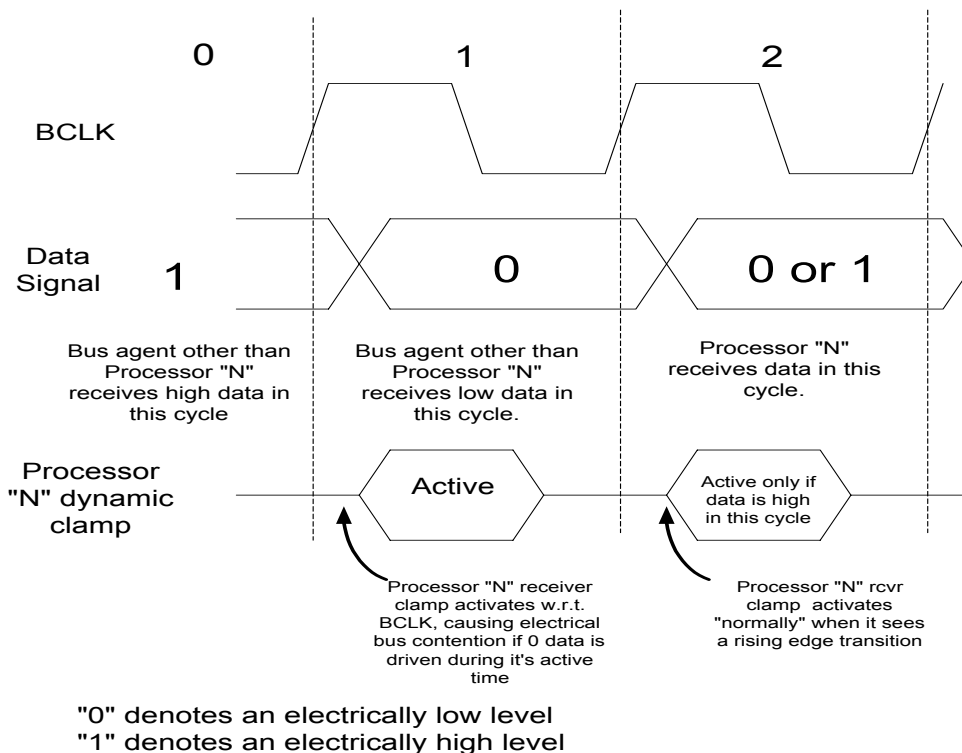
Problem: Falling edge ledge push-out and undershoot may be seen on AGTL+ data and data bus ECC signals. The AGTL+ receiver's dynamic clamp circuit activates (i.e. clamps the signal to an electrically high level) in certain cycles when data is driven to an electrically low level by another agent.

Implication: This erratum only occurs on a processor that does not receive data in that particular cycle. More specifically, this erratum only occurs when a specific processor does not receive data in the current BCLK period, but receives data in the very next period. Therefore, the processor inducing this falling edge noise (on data and data bus ECC signals) will not actually read the data in that cycle. See below for an illustration of this erratum affecting a processor denoted Processor "N". The falling edge ledges and undershoots may affect the signal quality and/or timing at agents that receive data in that cycle. Therefore, the impact of this erratum is highly dependent on system bus design.

Workaround: Evaluate system bus signal quality and timing margin at the valid receiving agent as a result of this falling edge noise. Due to dependence upon system bus design, bus layout may be evaluated to determine the need for improvements in signal quality and timing margin at the valid receiving agent as a result of this receiver-induced falling edge noise.
